ALAMO CLAIM SERVICE

SAMPLE FILE

Insured: John Doe	Date of Loss: 12/23/2002
Claim #: 12345	Date received: 12/27/2002
Policy#: HO5158021	Date Contacted: 12/27/2002
Adjuster: PETER PERRINE	Date Inspected: 12/30/2002

Summary for Hail Damage

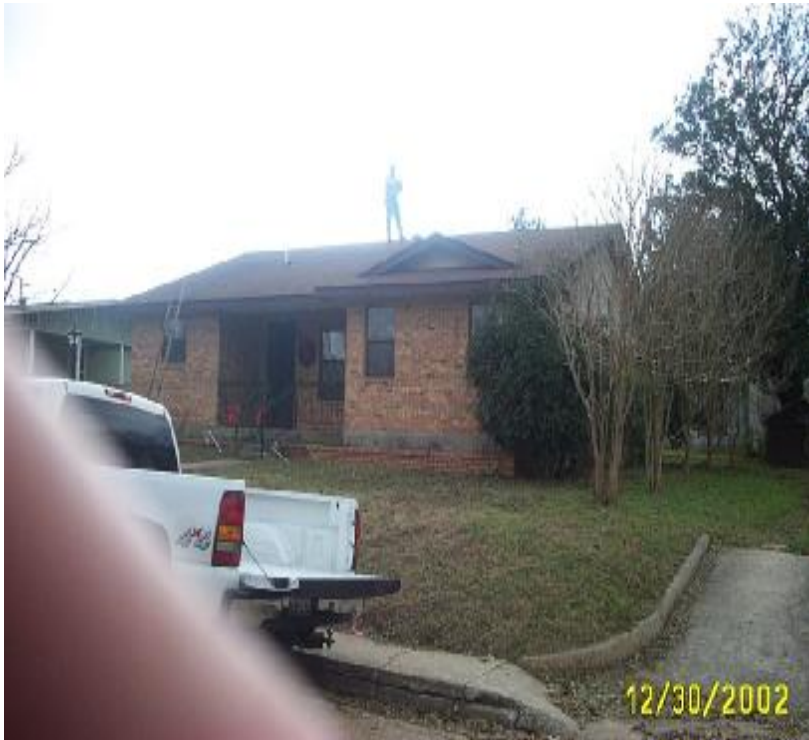
Picture # 1

Risk: 205 S 4th Street

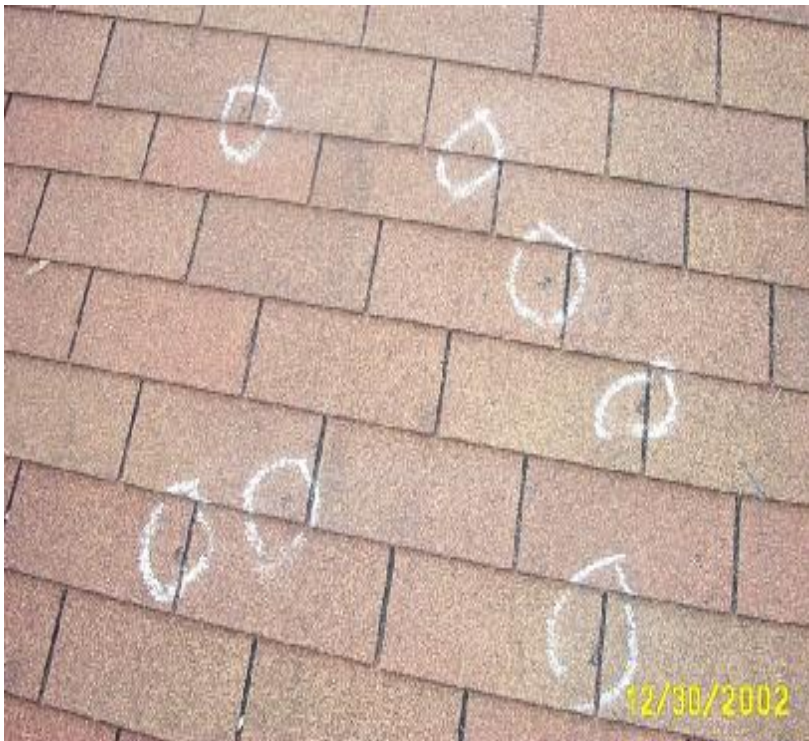
Picture # 2

hail damage to front slope

exceeded 20-30 hits per SQ

DESCRIPTION	QNTY	UNIT COST	RCV	DEPREC.	ACV
Hail damage to the roof in excess of 20-30 large hits per SQ. Hail also knicked up the fascia on the north side of the house. Shingles are approximately 6-8 years old and were in fair to good condition prior to the hail storm.					
Remove 3 tab - 20 yr. - composition shingle roofing - incl. felt	23.44 SQ	20.00	468.80	0.00	468.80
3 tab - 20 yr. - composition shingle roofing - incl. felt	26.00 SQ	75.00	1,950.00	<585.00>	1,365.00
Prime & paint exterior fascia - wood, 4" - 6" wide	76.00 LF	0.77	58.52	<5.85>	52.67
R&R Roof vent - turbine type	1.00 EA	61.08	61.08	<5.66>	55.42
Room Totals: Roof			2,538.40	<596.51>	1,941.89

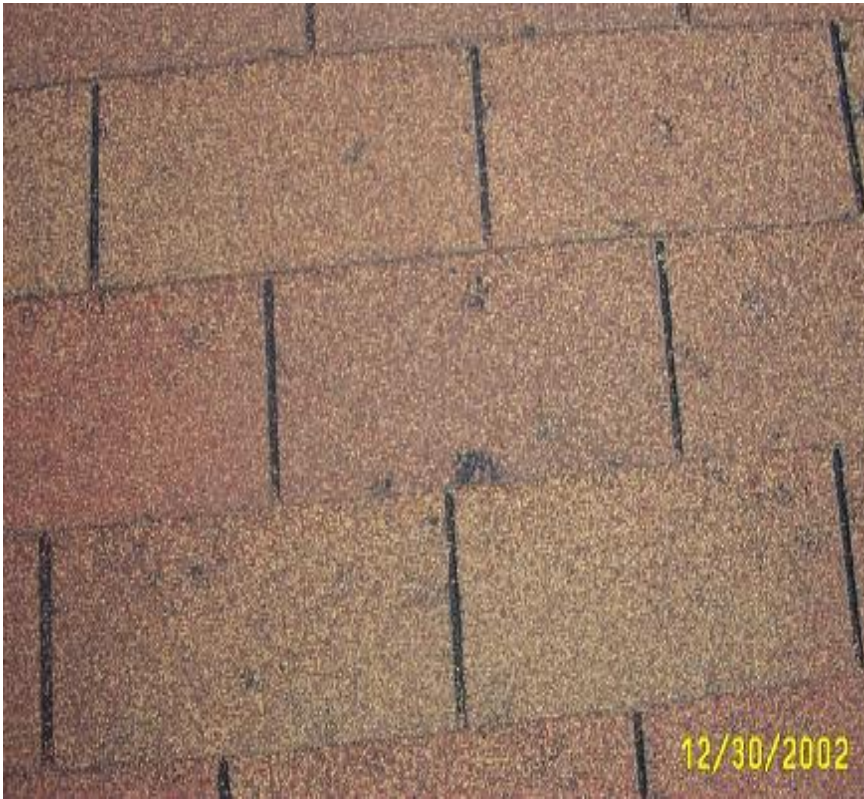
Picture # 3

Close up of hail damage to rear

slope. Hits exceeded 20-30 hits/SQ

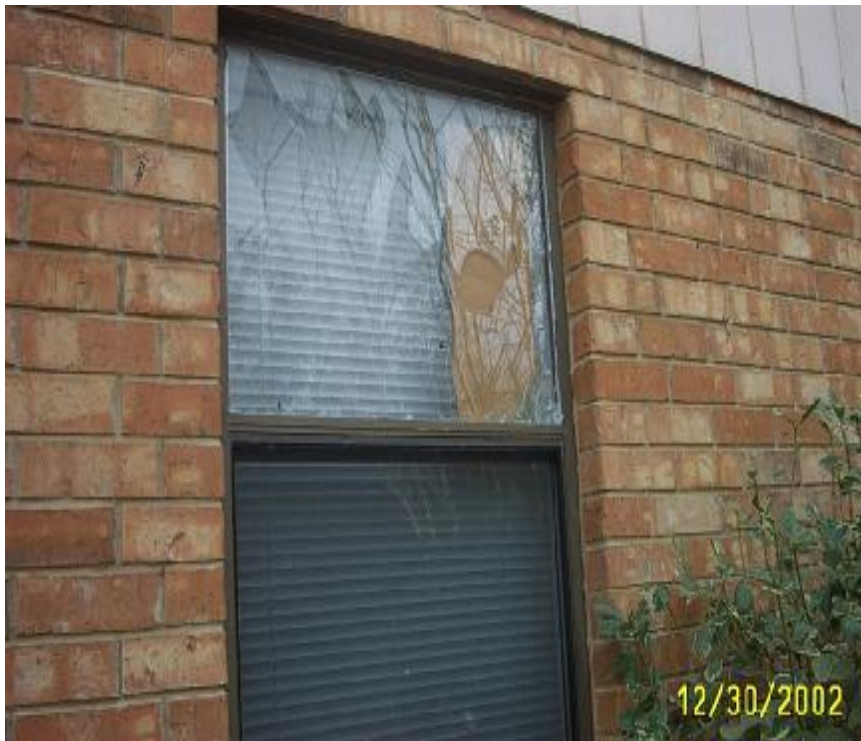
Picture # 4

Broken double pane glass on north

side of the home. All other

windows on north side of the home

are fogged up on the top pane.

Screens are also damaged.

DESCRIPTION	QNTY	UNIT COST	RCV	DEPREC.	ACV
Three windows on the north side had broken panes and the other three windows are now fogged up. hail dings are all over the screens. Will replace individual panes and screens. Window frame is not damaged.					
Window screen, 10 - 16 sf	4.00 EA	19.11	76.44	<7.64>	68.80
Window screen, 1 - 9 sf	2.00 EA	14.01	28.02	<2.80>	25.22
Reglaze double-pane thermal window unit, 1 - 9 sf	6.00 EA	105.98	635.88	0.00	635.88
There are small hail chips in the paint on the siding right side of the house.					
Seal & paint/finish wood siding	128.00 SF	0.65	83.20	<8.32>	74.88
Room Totals: Right Elevation			823.54	<18.76>	804.78

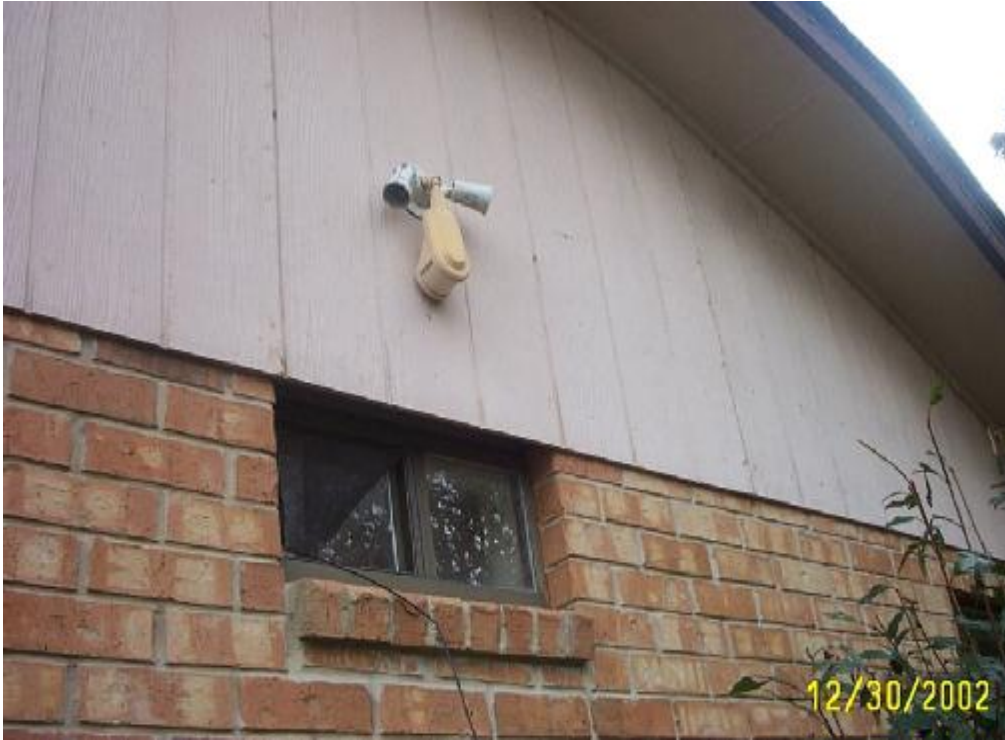
Picture # 5

Damage to bathroom window and
screen and exterior light.

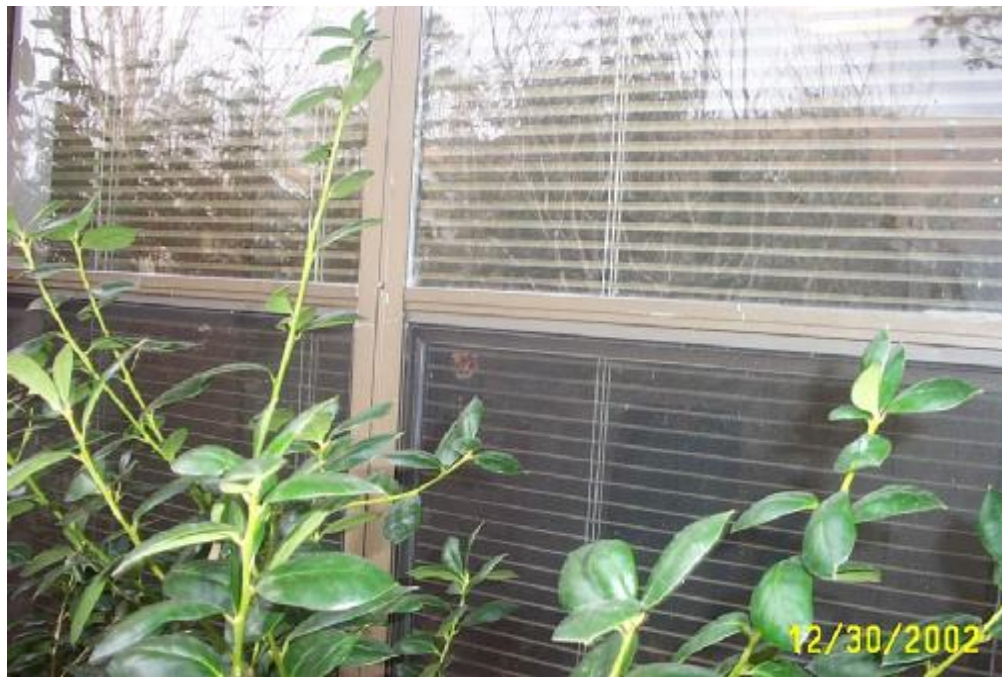
Picture # 6

Broken window glass on north side
window near rear of home.

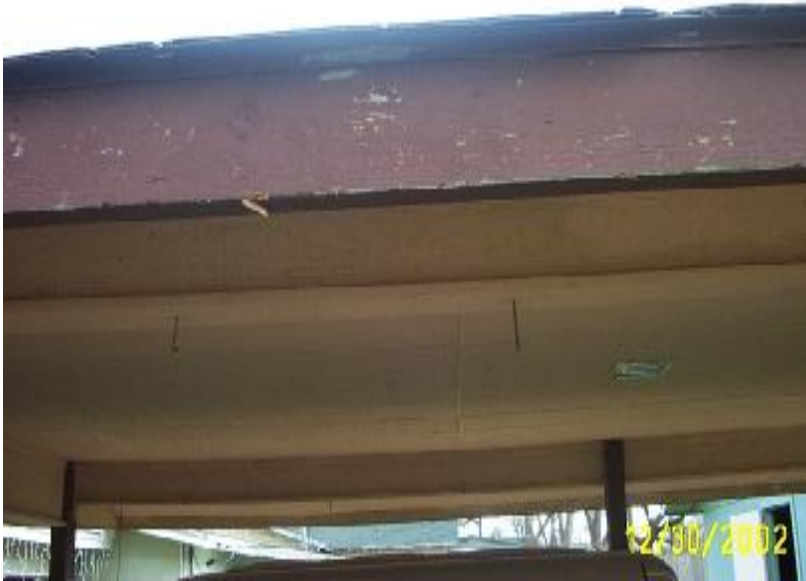
Picture # 7

Hail damage to north side fascia.

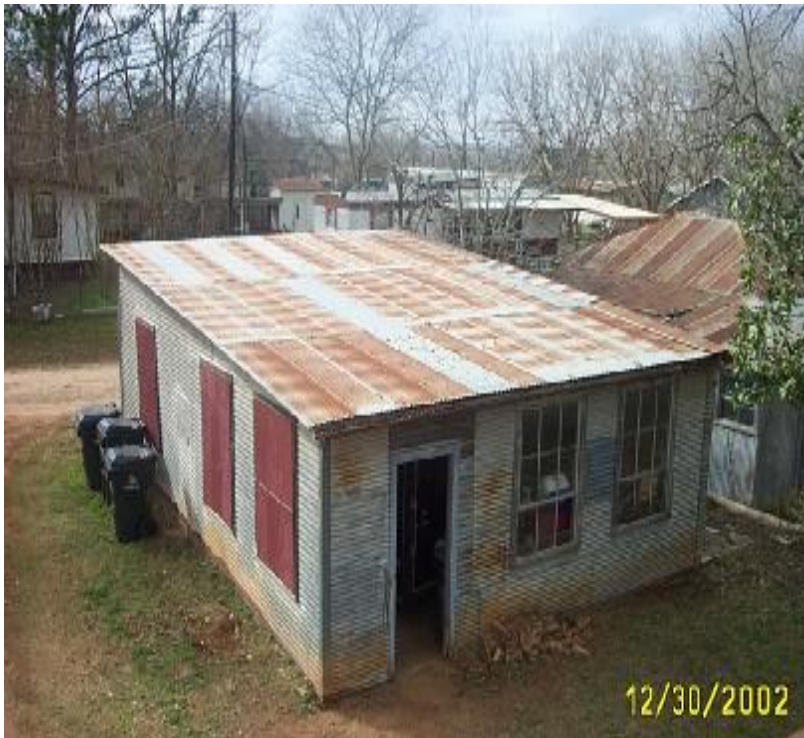
Picture # 8

Rear garage.

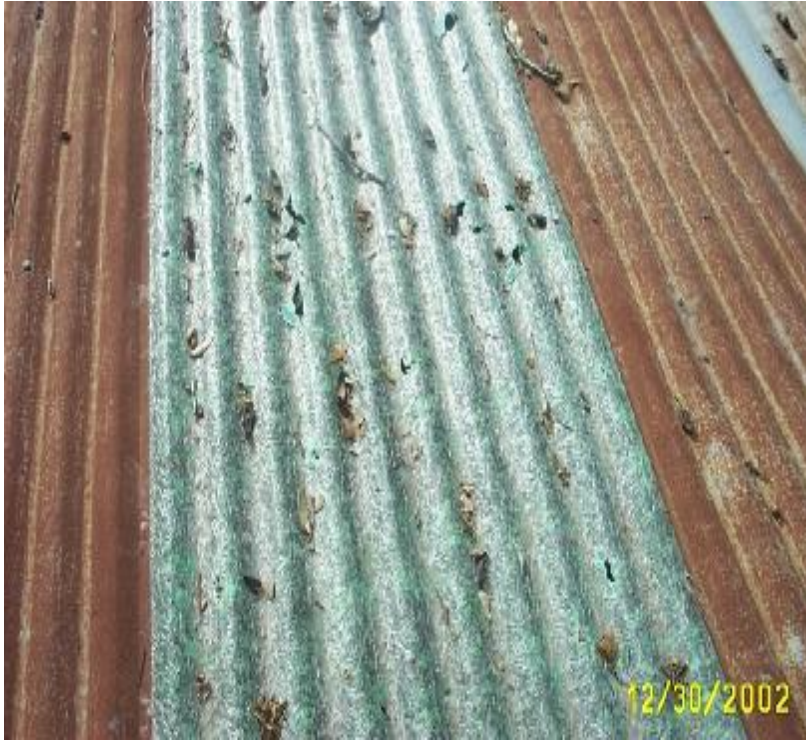
Picture # 9

Garage roof panel has hail damage

to one fiberglass panel and one

light weight tin panel.

DESCRIPTION	QNTY	UNIT COST	RCV	DEPREC.	ACV
Detached garage has very old tin roof with one panel dinged by the hail and one fiberglass skylight panel with holes from the hail. Will allow metal roofing minimum charge for this roof.					
Metal roofing - Minimum charge	1.00 EA	260.00	260.00	0.00	260.00
Room Totals: Garage			260.00	0.00	260.00

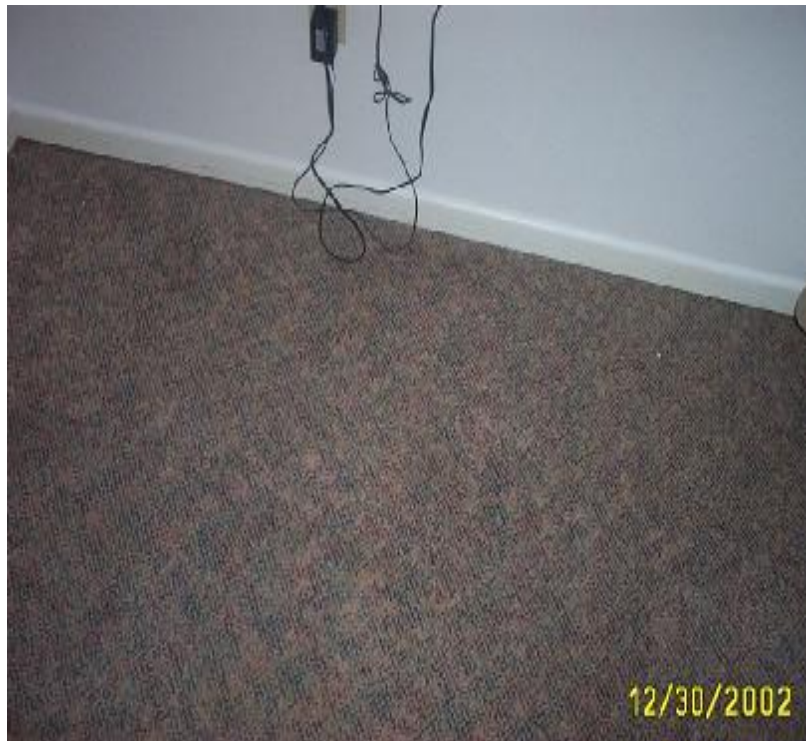
Picture # 10

Glass pieces in carpet from broken

window. Carpet is low pile and can

be cleaned. No other interior

damage.

DESCRIPTION	QNTY	UNIT COST	RCV	DEPREC.	ACV
Small amounts of glass are in short pile carpet which can be cleaned.					
Clean and deodorize carpet	198.60 SF	0.28	55.61	0.00	55.61
Room Totals: Bedroom			55.61	0.00	55.61
