ALAMO CLAIM SERVICE

SAMPLE FILE

Insured: John Doe	Date of Loss: 12/23/2002
Claim #: 12345	Date received: 12/27/2002
Policy#: HO5158021	Date Contacted: 12/27/2002
Adjuster: PETER PERRINE	Date Inspected: 12/30/2002

Hail damage to roof, siding and windows. Several glass panes were broken.

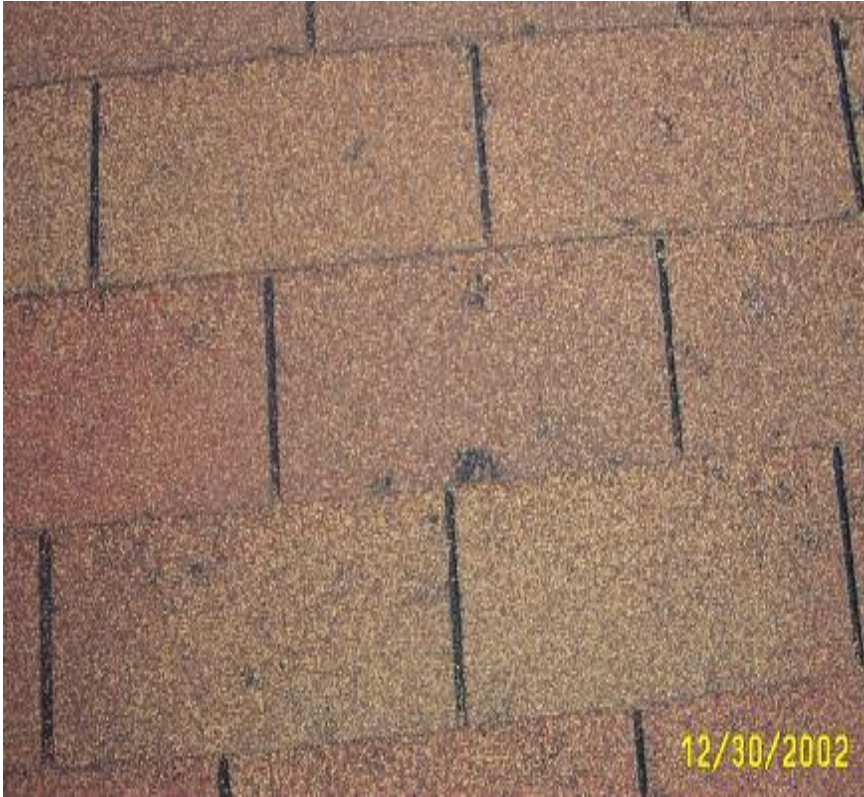
Picture # 3

Close up of hail damage to rear

slope. Hits exceeded 20-30 hits/SQ

DESCRIPTION	QNTY	UNIT COST	RCV	DEPREC.	ACV
Hail damage to the roof in excess of 20-30 large hits per SQ. Hail also knicked up the fascia on the north side of the house. Shingles are approximately 6-8 years old and were in fair to good condition prior to the hail storm.					
Remove 3 tab - 20 yr. - composition shingle roofing - incl. felt	23.44 SQ	20.00	468.80	0.00	468.80
3 tab - 20 yr. - composition shingle roofing - incl. felt	26.00 SQ	75.00	1,950.00	<585.00>	1,365.00
Prime & paint exterior fascia - wood, 4" - 6" wide	76.00 LF	0.77	58.52	<5.85>	52.67
R&R Roof vent - turbine type	1.00 EA	61.08	61.08	<5.66>	55.42
Room Totals: Roof			2,538.40	<596.51>	1,941.89
